HA-1109

THE PRESBYTERIAN CHURCH OF HAVRE DE GRACE
Havre de Grace, Md.

INVENTORY FORM FOR STATE HISTORIC SITES SURVEY

The Presbyterian Church of Havre de Grace

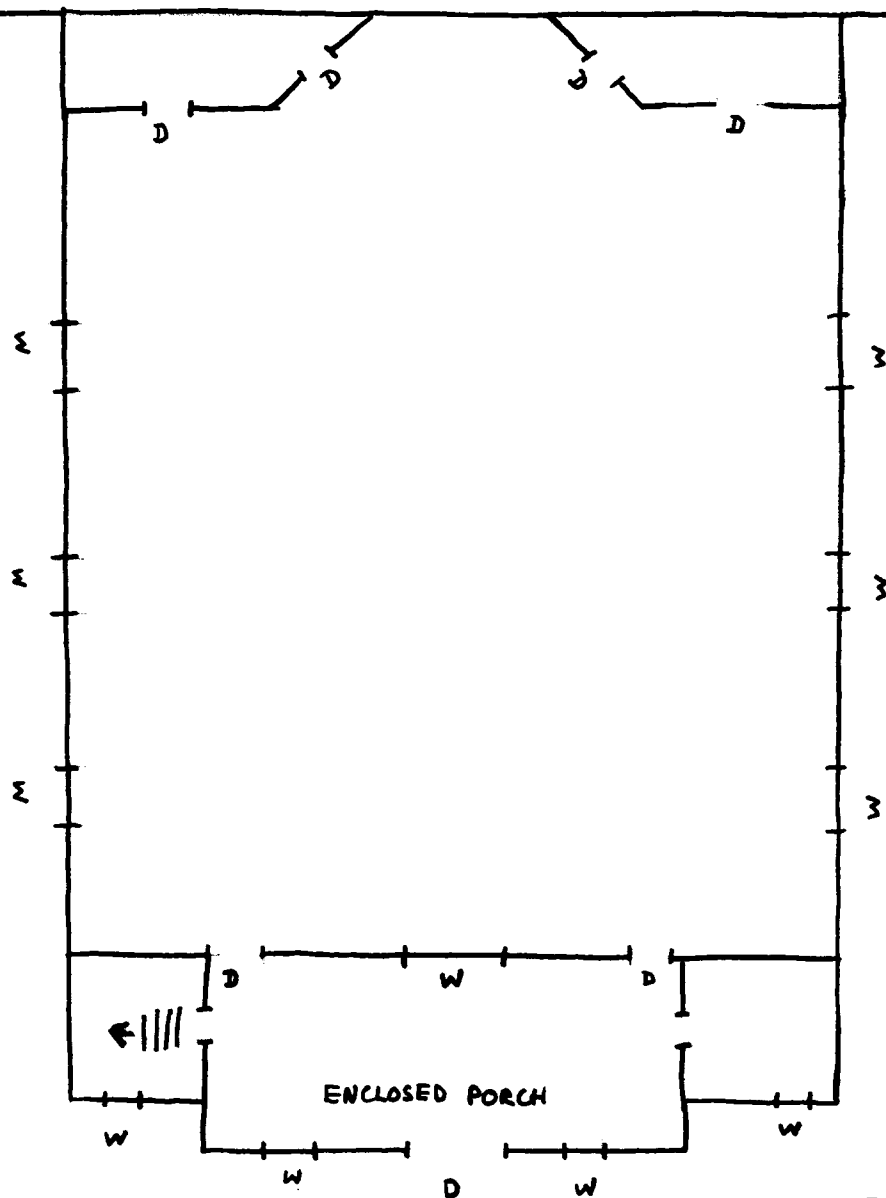
APPROXIMATE PLAN

NEW
WING

WING

PRESBYTERIAN CHURCH

NOT TO SCALE

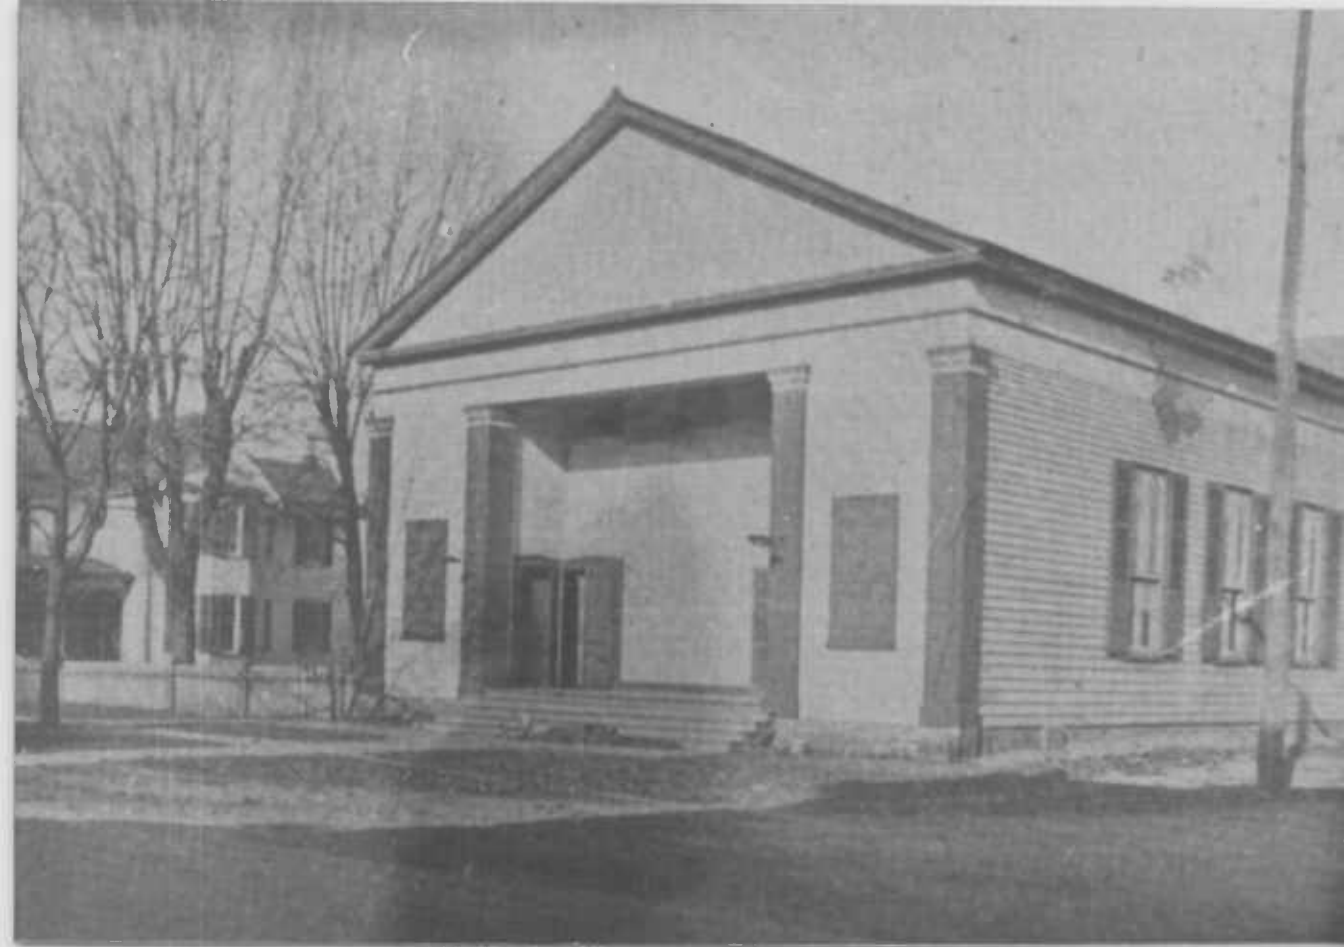
7

PRESBYTERIAN CHURCH HA-1109
551 FRANKLIN ST, HAVRE DE GRACE
SOUTH FACADE, BEFORE 1884
MARION MORTON (PHOTOCOPY) NOV, 76
ORIGINAL AT SUSQUEHANNA MUSEUM, H. DE G.
